SB: Water Computer

Article : 1881, 1882, 1883, 1884, 1885

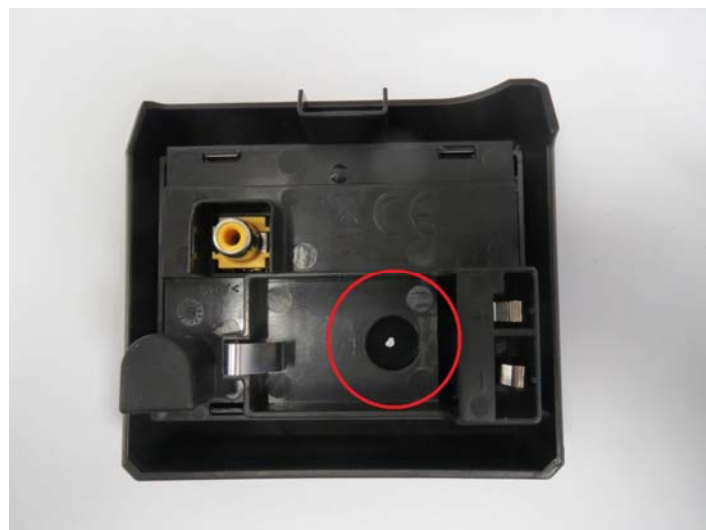
- silver dot in the battery compartment:

The whole stock was reworked in June 2014 by reprogramming the control units. These units can be identified by :

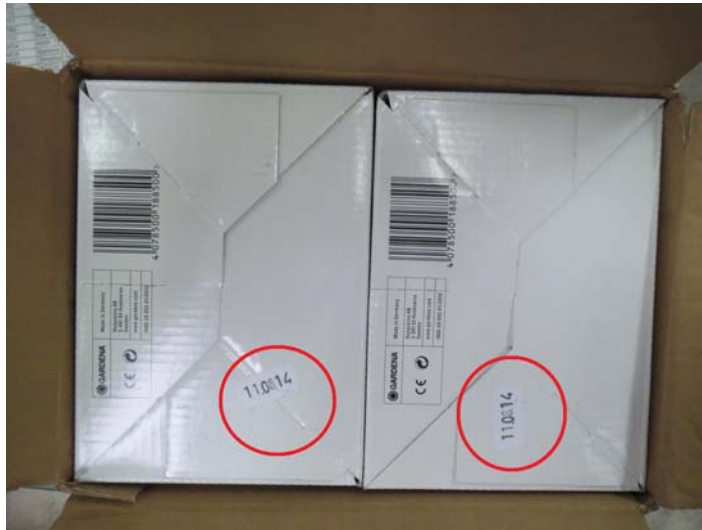
- date sticker on the bottom of the card board:

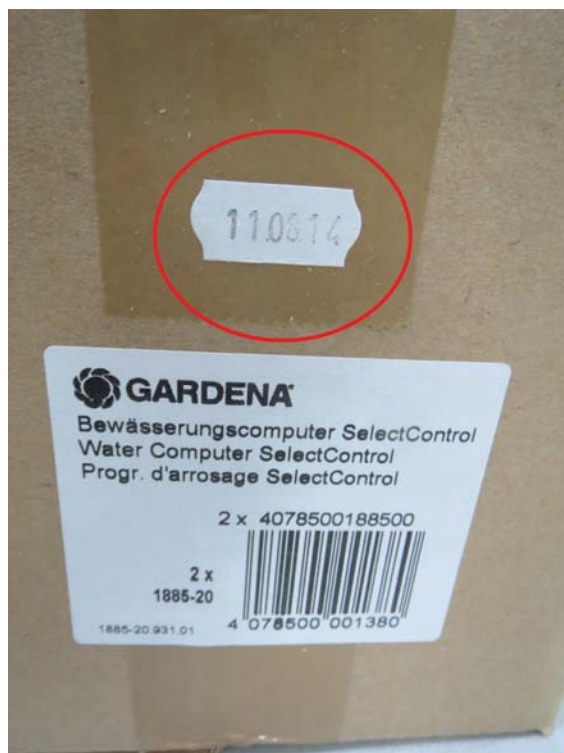
- additional date sticker on the side of the covering box:

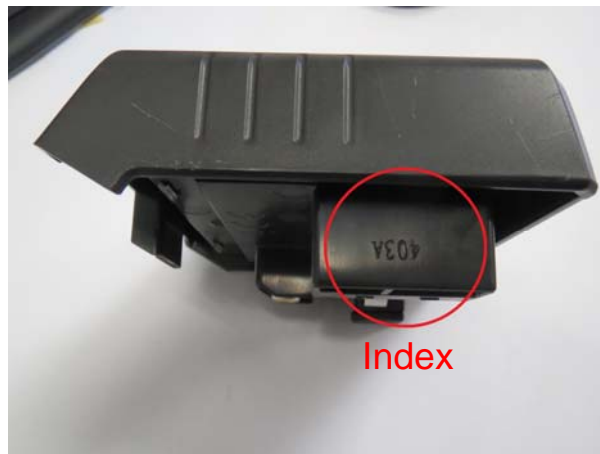
- on article 1881, 1882 and 1884 : new production index "**B**"
- on article 1883 and 1885: new production index "**C**"

For the production of new control units the index was changed:
