SB: **Electric Lawnmower PowerMax™ 1200/32**

Article : 5032

Reason: Mower suddenly switch off:

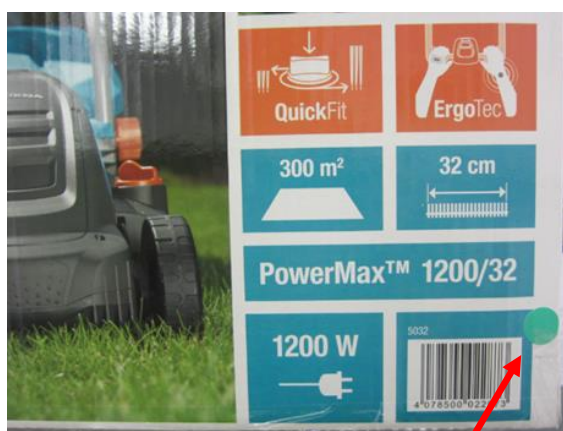
sticker

All mowers from production date 2018 with index "C" will have a new type of TCO with reduced cool down times. Reworked mowers from 2017 have a green dot on the carton.

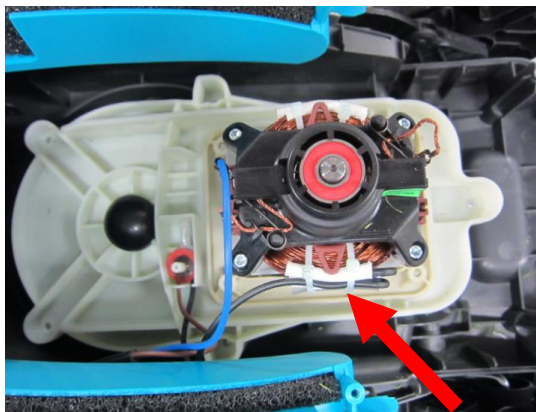
- 1.1 Location of the TCO: directly fixed to the motor winding
