SB: **Electric Lawnmower PowerMax™ 1200/32**

Article : 5032

Reason: Mower suddenly switch off:

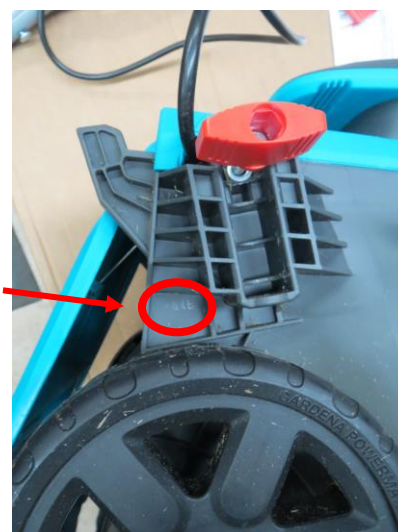
All mowers from production date 2018 with index "C" will have a new type of TCO with reduced cool down times. Reworked mowers from 2017 have a green dot on the carton.

sticker

index
