SB: **Garden Pump 3000/4**

Article : **1707**

Reason: Danger of overtorquing the draining plug.

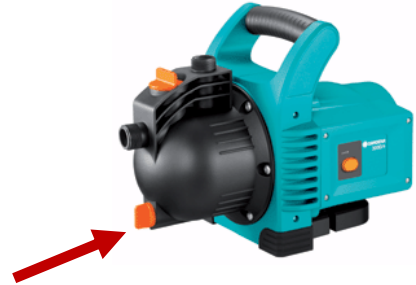
On pumps before index 1406H it can happen that the thread for the draining plug inside the pump body is too short and can be overtorqued . For service purposes a new draining plug with a longer thread was created as a spare part. These plugs will fit on pumps with index later than 1406H too.

Actions: Modification of the thread in the pump body since index 1406H

Spare parts: New locking screw, red art.-no. 1707-00.900.21

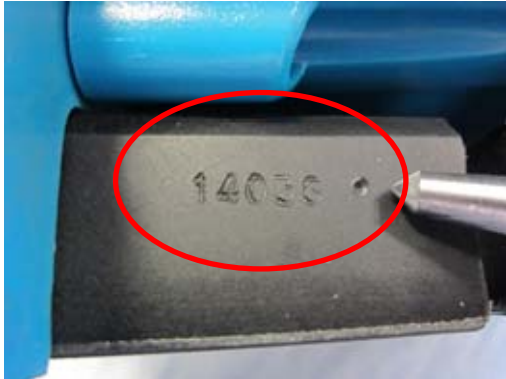
mark beside the index

Rework : The whole stock in Ulm was reworked and these pumps can be identified by a mark beside the index and a green sticker on the box and the palett :

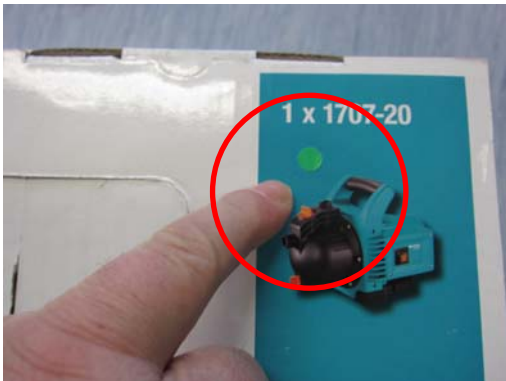
green sticker on the box

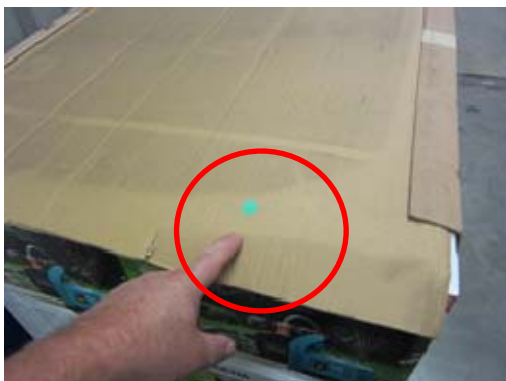
green sticker on the pallet
